WEATHERING AND DETERIORATION OF CARBONATE STONES FROM HISTORICAL MONUMENTS: A REVIEW

Abstract: *The degradation of historical monuments due to atmospheric and anthropogenic factors is a frequently encountered phenomenon on all continents, being intensively investigated to understand the type and degree of damage and to choose an appropriate restoration method. Based on extensive bibliographic documentation, this study presents a comprehensive review of the physical, chemical, and biological weathering processes induced by extrinsic factors (atmospheric, biological, and anthropic) that lead to the deterioration of limestone and marble, the most common construction materials found in historic buildings of humanity's architectural heritage.*

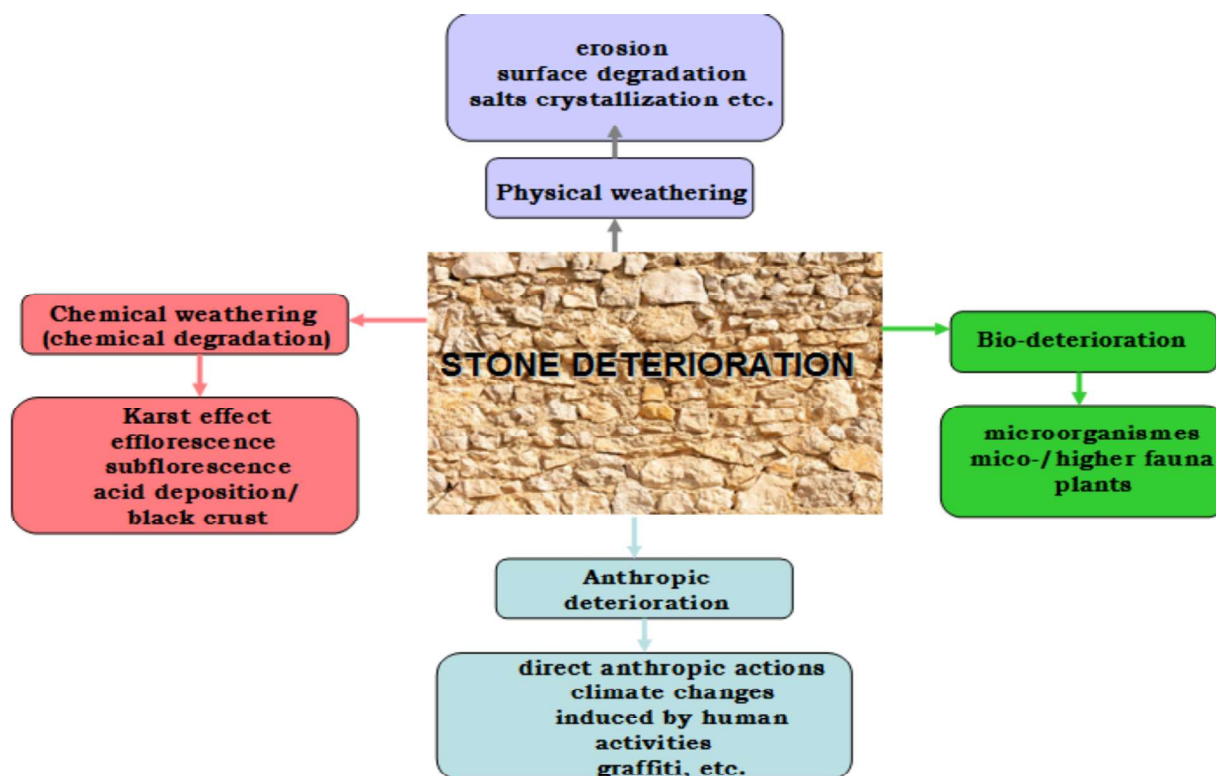
Figure 4. Deterioration types of the carbonate stones

In the following paragraphs, we will briefly present the most important natural and anthropogenic factors involved in the degradation of carbonate stone materials, emphasizing the weathering and deterioration processes generated by these factors. The deterioration types of the carbonate stones are schematically presented in **Figure 4**.

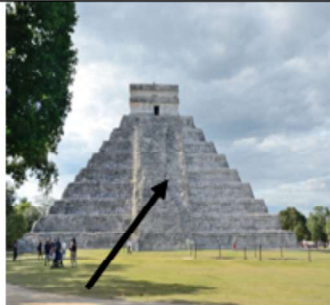
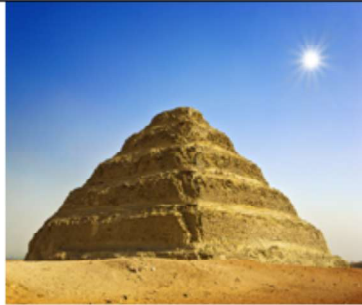
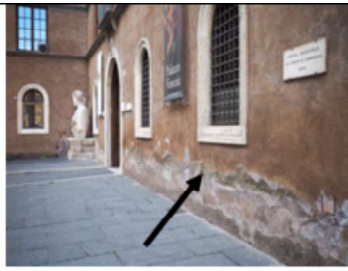
Figure 5. Heritages' deterioration due to physical weathering processes

Erosion of limestone building' surfaces		Spalling and delamination of limestone	Cracking and exfoliation of marble
Temple of Kukulcan, Chichen Itza Mayan	Step Pyramid of Djoser, Saqqara necropolis, Egypt,	Temple of Baal, Palmyra, Syria built in 32 A.D	G. Washington marble statue, Washington Square, N.Y.

Damage due to the water ascent by capillarity			Cracks generated by freeze/thaw cycles
Palazzo Venezia in St. Mark's Square, Rome, Italy	Marble facade, Palazzo Dogale, Grand Canal, Venice, Italy	Signum Gratiae monument, Arad, Romania photo by L.A.C

The presence of water can lead to the degradation of the stone's surface through expansion/contraction phenomena or freeze/thaw cycles, generating cracks, exfoliation, spalling, delamination, or descaling of the contour (Fistos et al., 2022; Pappalardo et al., 2022; Vidal et al., 2019). In **Figure 5**, some heritage structures degraded by physical weathering processes are exemplified.

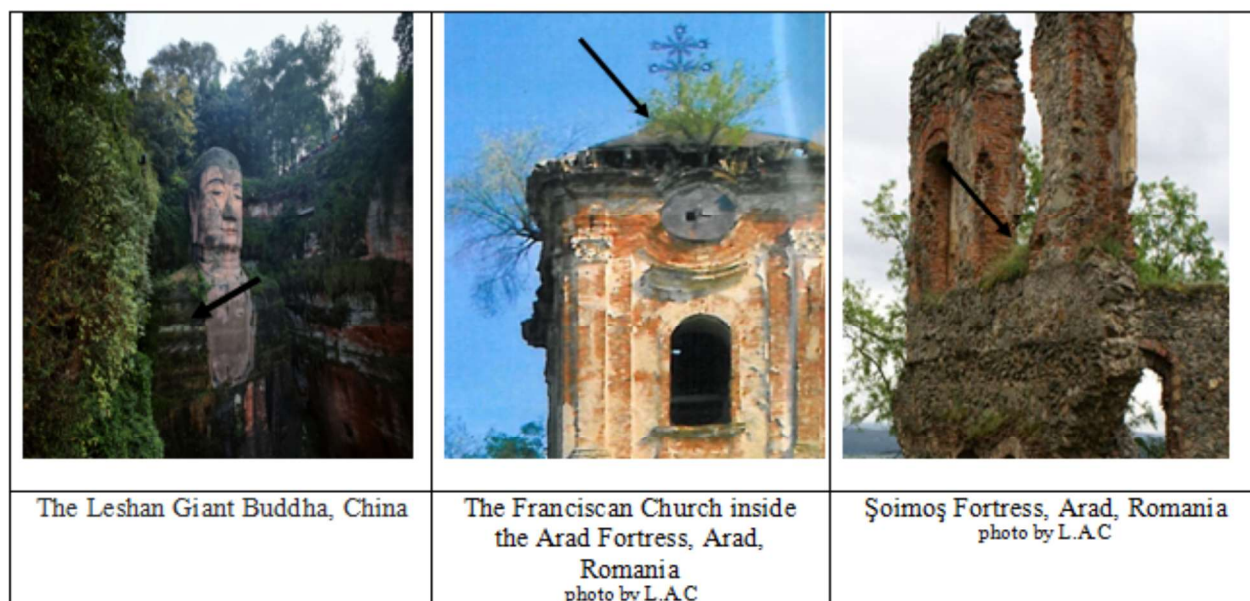
Figure 7. Plants growing between stones of historic buildings

The damage caused by the development of some plants or plant roots (**Figure 7**.) in the existing cracks of the constructions can also be considered physical weathering (Mascaro et al., 2022).
